Re: Request for Information

United Talmudic Academy of Kiryas Joel (UTA of KJ) - Bakertown Road, Kiryas Joel NY

A. INTRODUCTION

Photographs of United Talmudical Academy of Kiryas Joel on June 13, 2013. htner, P.E., Environmental Engineer, Nikon Coolpix P510, Kiryas Joel, NY
Photo ID		
No.	Photo Date	Photo Description
		View from the Highland Brook on the North Side. Roots from the trees
DSCN1297	6/13/2013	standing on the other bank are visible potentially due to a shift in the brook
		locations associated with construction activity.
DSCN1298	6/13/2013	Flow path channel under the silt fence. Not buried into the ground as required.
DSCN1299	6/13/2013	Video log showing a small turbid flow under the silt fence that is going into the Highland.
DSCN1300	6/13/2013	Photo showing a small turbid flow under the silt fence going into the Highland Brook.
DSCN1301	6/13/2013	Photo showing a small turbid flow under the silt fence going into the Highland Brook.
DSCN1302	6/13/2013	Rocks, rubble, and silt fencing around the property
DSCN1303	6/13/2013	Dried up flow of concrete visible on the left. Silt fencing and unnamed tributary of the Highland Brook on the eastern side of the site.

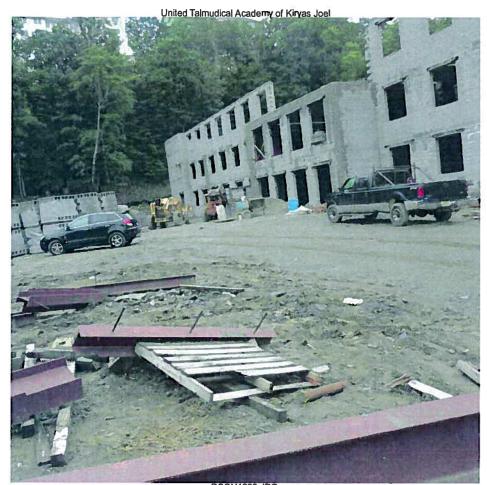
DSCN1293.JP 06/13/2013

DSCN1293	6/13/2013	West side of the building. Material and equipment stored on this side.
DSCN1294	6/13/2013	Flow pathway that goes around the edge of the silt fence to Highland Brook at the site entrance.
DSCN1295	6/13/2013	Flow pathway that goes around the edge of the silt fence to Highland Brook at the site entrance.
DSCN1296	6/13/2013	Flow pathway that goes around the edge of the silt fence to Highland Brook at the site entrance.

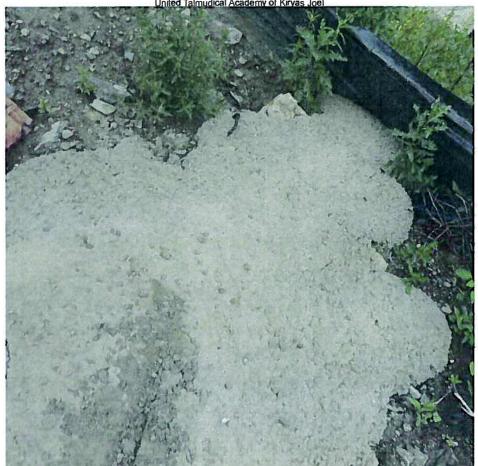
DSCN1304.JPG 06/13/2013

- 5. As shown in photos 1303 to 1305, there was apparent concrete washout from the site adjacent to a tributary of Highland Brook on the eastern side of the site. Part

DSCN1304	6/13/2013	Dried up flow of concrete located on eastern side of the site near another unnamed tributary of Highland Brook.
DSCN1305	6/13/2013	Dried up flow of concrete. Another tributary is found beyond the silt fence on the east side of the site. The rocks are seen in the channel, water is seen in the channel.
DSCN1306	6/13/2013	Sediment/Soils overtopping the silt fencing into the unnamed tributary of Highland Brook with water/standing water on the eastern side of the site. Rocks from the construction site are clearly shown impeding any sort of flow.
DSCN1307	6/13/2013	Silt fence is improperly secured and is failing.
DSCN1308	6/13/2013	Flow path on the East side of the site that goes under the silt fence into the unnamed tributary of Highland Brook on the east side of the site.
DSCN1309	6/13/2013	Video showing flow path on the East side of the site that goes under the silt fence into the unnamed tributary on the eastern side of the site.

B.1.j requires proper pollution prevention measures for the disposal of construction waste to prevent stormwater pollution.

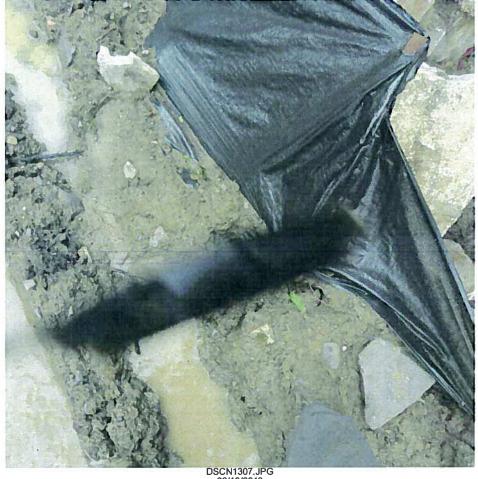
DSCN1307.JPG 06/13/2013 Unedited Digital Photos

- 2. Photograph 1306 shows material overtopping the silt fence along the eastern tributary to Highland Brook. Photos 1307 and 1308 and video 1309 show a turbid discharge under the silt fence into the tributary on the eastern side of the site. Photo 1310 and video 1311 show an unstablized soil/rock/material storage pile adjacent to the eastern tributary of Highland Brook.

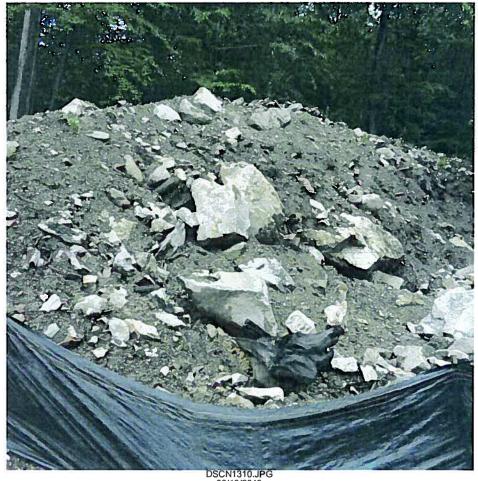
DSCN1310.JPG 06/13/2013 Unedited Digital Photos

DSCN1310	6/13/2013	Photo of unstabilized mixture of rock and soil seen above the unnamed tributary on the eastern side of the site.
DSCN1311	6/13/2013	Video log showing unstabilized mixture of soil and rock seen above the tributary on the east side of the site.
DSCN1312	6/13/2013	Building under construction. Construction debris is seen at the site and they are not placed in a dumpster and are exposed to stormwater.
DSCN1313	6/13/2013	Construction site looking towards the entrance of the site. Construction materials, the building and construction equipment seen at the site.
DSCN1314	6/13/2013	Gaps under the silt fence enabling sediments to discharge from the site.
DSCN1315	6/13/2013	Flow pathway under the improperly secured silt fence towards the unnamed tributary on the western side of the site.
DSCN1316	6/13/2013	Flow pathway under the improperly secured silt fence towards the unnamed tributary on the western side of the site.

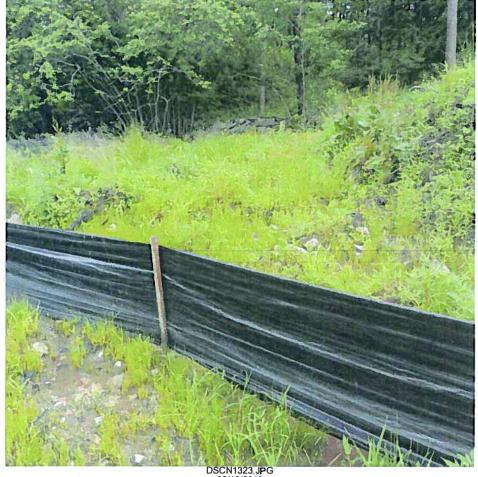
DSCN1323 JPG 06/13/2013 Unedited Digital Photos

DSCN1323	6/13/2013	Silt fence crossing over the northern portion of the unnamed tributary on the western side of the site. This is not an appropriate installation of the silt fence. Vegetated material storage pile seen beyond the silt fence on western side of site.
DSCN1324	6/13/2013	Flow pathway under the silt fence into the unnamed tributary on the western side of the site.
DSCN1325	6/13/2013	Flow channel cut under the silt fence by flowing water.
DSCN1326	6/13/2013	Flow channel cut under the silt fence by flowing water.
DSCN1327	6/13/2013	Flow channel cut under the silt fence by flowing water.
DSCN1328	6/13/2013	Flow pathway under the silt fence into the unnamed tributary on the western side of the site.
DSCN1329	6/13/2013	Unnamed tributary on western side of site and silt fencing. Gaps are visible under the silt fence.
DSCN1330	6/13/2013	Flow path that extends from under the construction material to beyond the silt fencing on the western side of the site.

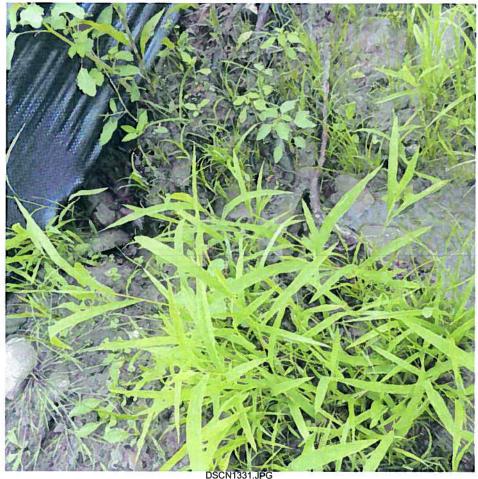
DSCN1331.JPG 06/13/2013 Unedited Digital Photos

DSCN1331	6/13/2013	Flow channel cut under the silt fence by flowing water.
DSCN1332	6/13/2013	Flow path that extends from under the construction material to beyond the silt fencing into the unnamed tributary on the western side of the site.
DSCN1333	6/13/2013	Unnamed tributary and silt fencing. Gaps are visible under the silt fence.
DSCN1334	6/13/2013	The visible point of origin of the unnamed tributary on the west side. It starts from under the rubble located inside the silt fence perimeter of the work site. This water is slightly tinted as well. Silt fence crosses over the unnamed tributary
DSCN1335	6/13/2013	The visible point of origin of the unnamed tributary on the west side. It starts from under the rubble located inside the silt fence perimeter of the work site. This water is slightly tinted reddish/brown.

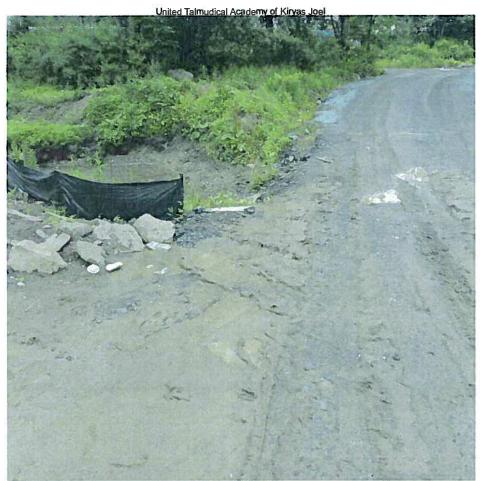
DSCN1340.JPG 06/13/2013

DSCN1340	6/13/2013	Multiple water runoff pathways are able to carry sediments under and around the silt fence into the flowing Highland Brook at the site entrance.
DSCN1341	6/13/2013	Signs of sediment being washed around the silt fence into Highland Brook are visible at the site entrance.
